# PROPERTY INSPECTION REPORT

**Date of Inspection:** 09/08/2026

**Address of Inspected Property:** 157 Riverside Ave., Weatherford, Texas, 76088

**Name of Inspector:** Randall C. Wooten

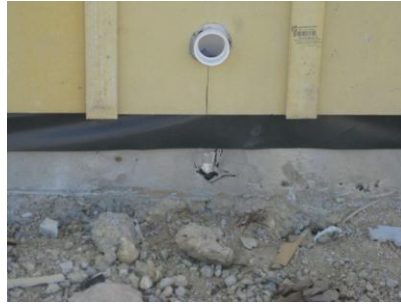
- Exterior: PVC drain line was visible on the edge of the foundation. This should be corrected.

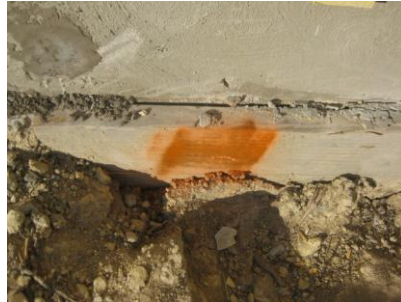
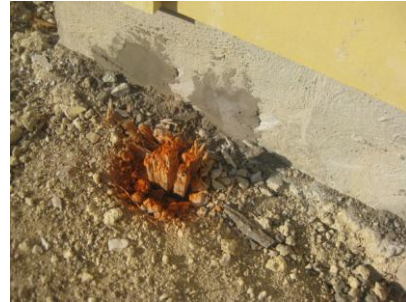
- Exterior: Foundation form board and grade stakes observed. These board are conducive to termite activity and should be removed.

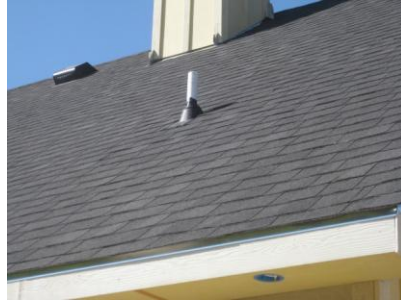
- Roof: White PVC (plastic) vent pipes should be painted a dark color as the PVC will deteriorate from the sun's ultra-violet radiation if not protected.

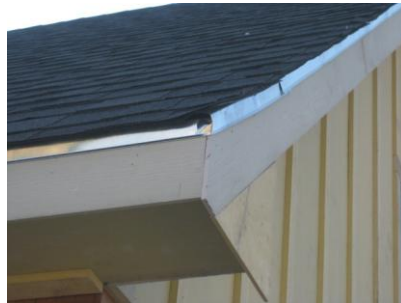
- Roof: Metal drip edge was damaged near the front entry point.

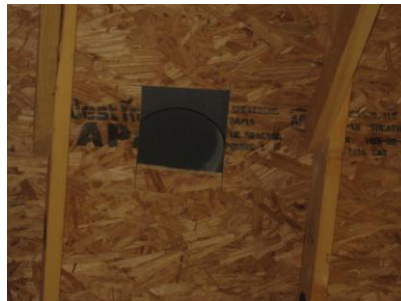
- Attic: If spray foam is to be applied to the roof decking. The attic vents are counterproductive.  
If spray foam is being applied to the ceiling joist area. The attic will need supply air. This is not a sealed attic system if applied to the ceiling joist.
- Attic: There was no soffit venting or gable vents. The attic did have roof vents present. The opening was not properly cut to allow air flow.

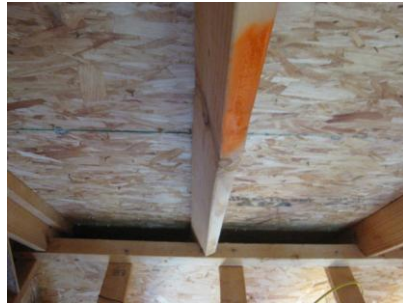
- Attic: Roof rafter was noted to be twisted and needs to be corrected.

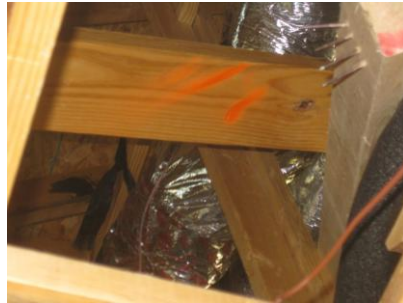
- Attic: A 2x6 brace was noted in attic. This board was not attached and should be removed or secured.

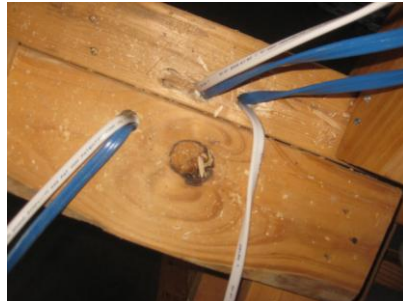
- Attic: Top plate penetrations should be sealed to reduce air flow.

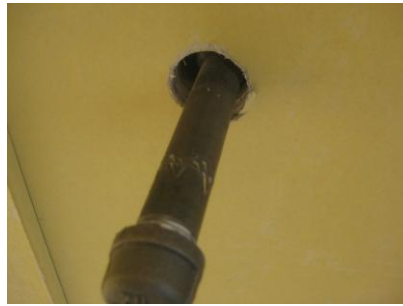
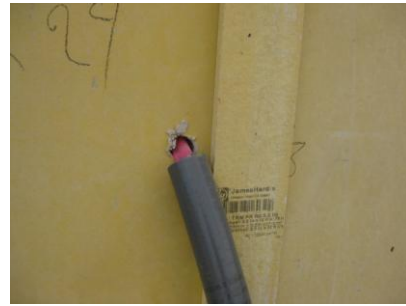
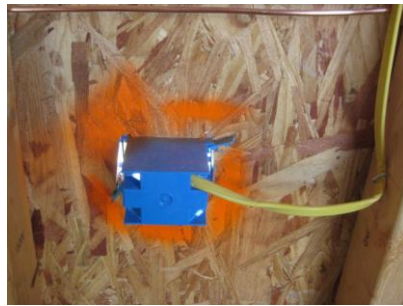
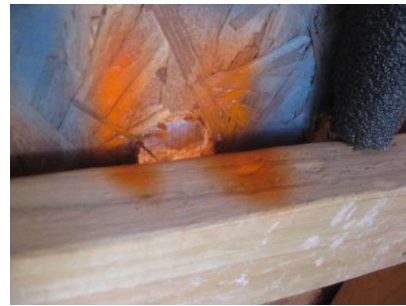
- All exterior siding penetrations should be sealed to prevent air loss and infiltration of moisture. The penetration should have been sealed behind the siding. These should be sealed with tape then mastic not just spray foamed over.

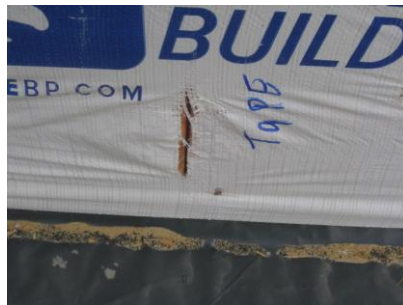
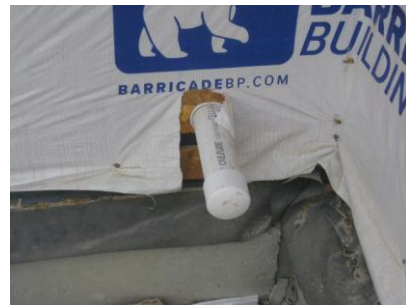
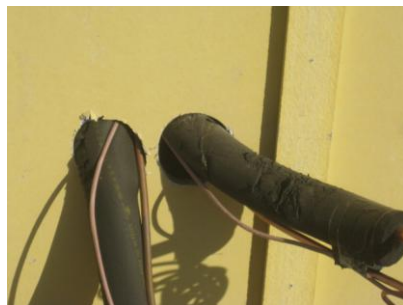
- Exterior: The house wrap was damaged and should be taped at every seam or damaged area.

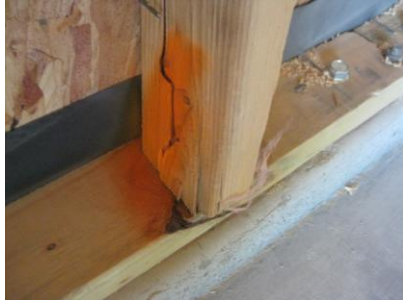
- Interior: Numerous damaged wall studs were discovered. Some not all were identified with paint.

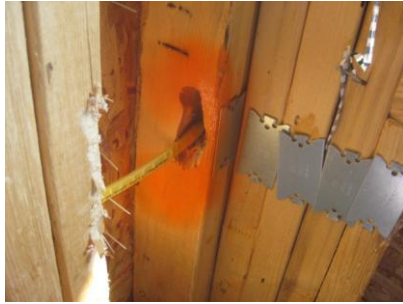
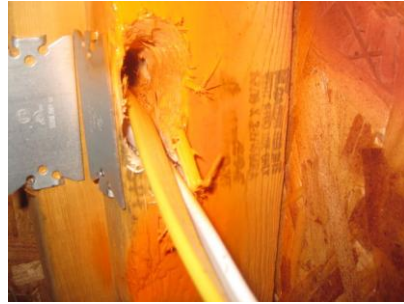
- Interior: Excessive boring was noted on wall studs. For bearing walls, a hole should not exceed 40% of the stud

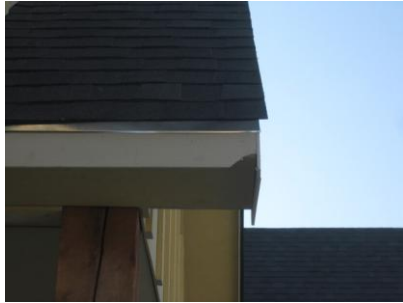
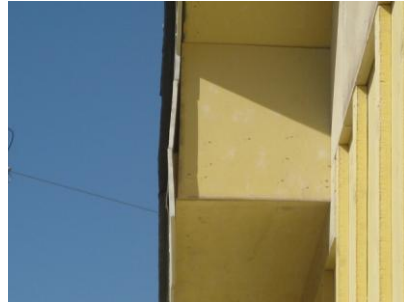
- Exterior: Damaged fascia boards were noted.

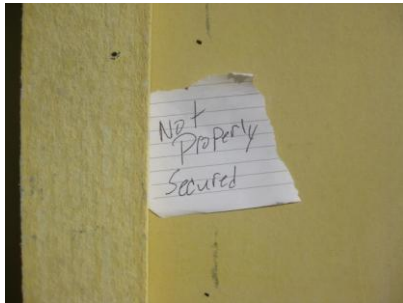
- Exterior: Several of the batten strips were not adequately attached.

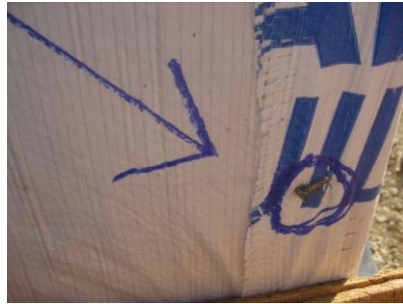
- Exterior: All nails should be driven flush or removed from exterior surface. Several nails will need to be removed from interior boards prior to dry wall installation.

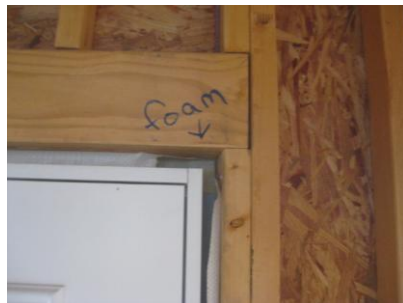
- Back Patio: The door swings the wrong direction per client.
- All window and door frames should be sealed with low expansion foam.

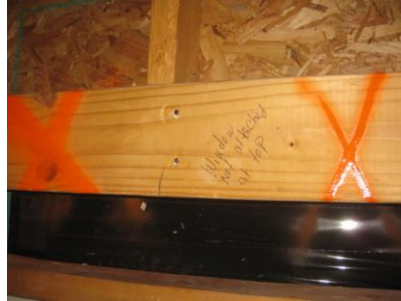
- Attic: The opening for this window appears to have been cut too large. The window was not attached at the top edge. Improperly flashed as well.

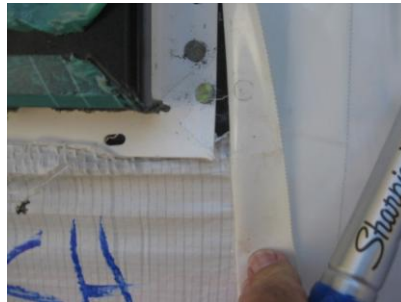
- Exterior: The nails in the bottom flange had been driven in too far and have damaged the flange. The tape did not touch the nail flange.

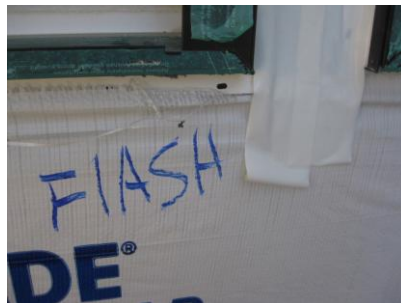
- Exterior: The window frames do not appear to be properly sealed/flashed or taped. I suggest all windows be taped at the flange and the tape secured. In several places the frame was not taped only covered by the house wrap. Tape was only noted on window sill not sides of most frames. Flashing tape was loose near windows, which indicates the tape had not been rolled as required by most Mfg. instructions. Flashing tape was loose near windows.

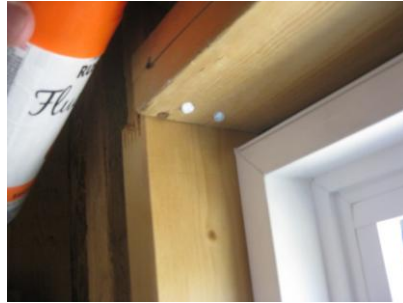
- Interior: All window and door frames should be sealed with low expansion foam.

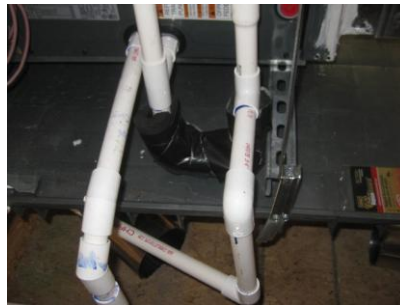
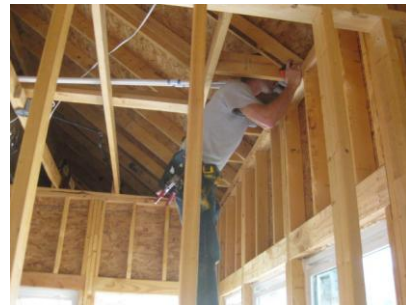
- Attic: The HVAC P trap was not properly insulated in the attic. The P trap holds cold water from the A coil. The condensation that will form on the pipe exterior often drips onto insulation and the sheet rock below. The standards state. Mechanical system piping capable of carrying fluids above 105°F or below 55°F shall be insulated to a minimum of R-3.  
The condensation drain line also ran uphill. I showed this to the tradesman and he said he would correct it.  
I suggest you consider having the drain line insulated near the north wall, where it exits to the soffit area.

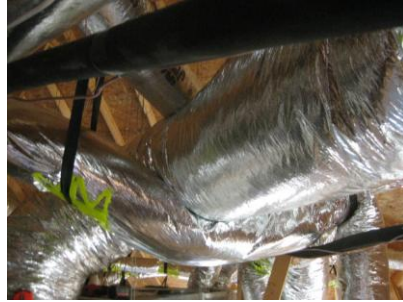
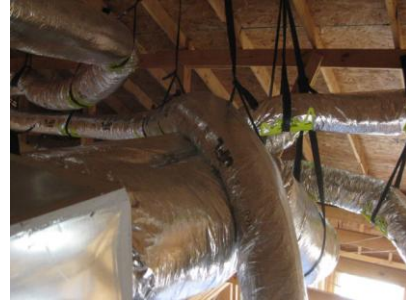
- Attic: The ductwork is in contact with each other. Manufactures now suggest having a minimum of 1" clearance between outer barriers to prevent condensation build up.

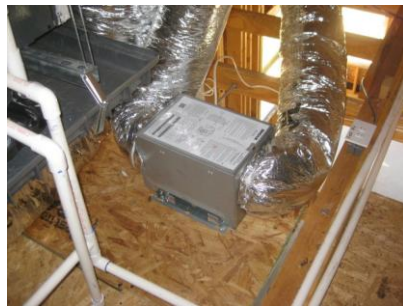
- Attic: Fresh air vent system that brings fresh outdoor air inside. The duct work terminates on gable end. It would have been better to route this duct to back patio. The air intake would have been from a shaded area which would be cooler than gable end. The patio would also reduced chance of water entry.

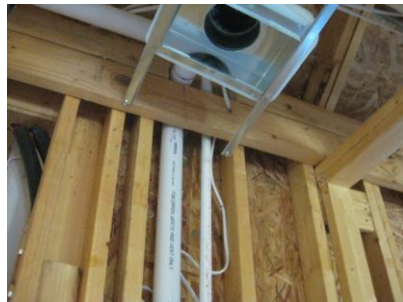
- Powder Room: A register was loose at the ceiling mounting position.
