1306 Timber Ridge  
Weatherford Tx. 76088  
Professional TREC # 8726-PI  
[randall@alertinspector.com](mailto:randall@alertinspector.com)

**Prepared for:** A Happy Client

**Concerning:** 157 Your New Home, Aledo, TX, 76008

# PROPERTY INSPECTION REPORT

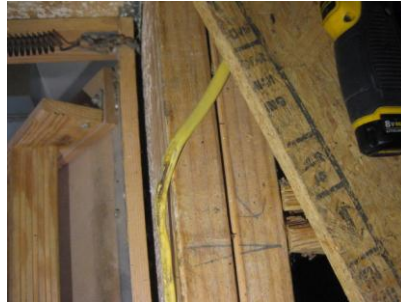
- Attic: Floor decking in attic is not properly secured in place, multiple areas where stepping on ends of boards can result in flooring popping up.

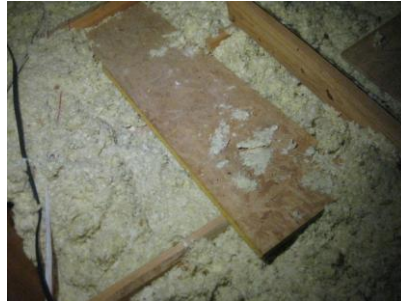
- Attic: There is evidence in the attic of rodents present in the attic due to droppings or tunnels in insulation being present. Recommend having a pest control specialist to inspect the attic. I could not determine if infestation was current or previous activity
- Attic: Attic floor is insulated with approximately six inches of fiberglass, blown insulation. Current standards call for minimum of ten inches, and you may wish to consider adding more for energy efficiency. R -38 is today's standard

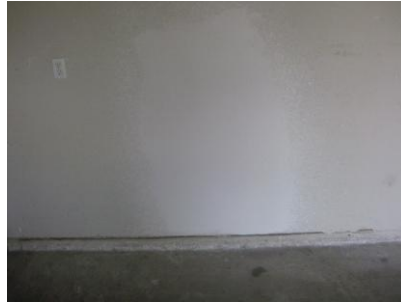
- **Garage:** There is evidence of recent patching and to the interior finish and prior interior finish repairs. This condition may limit the inspector's visual observations and ability to render accurate opinions as to the performance of the structure. Any past defects could reappear as time passes.

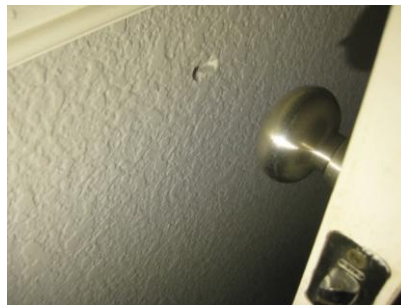
- **Downstairs in the middle bedroom:** There was not a door stop behind the door which has resulted in minor damage to sheetrock from the knob hitting wall.

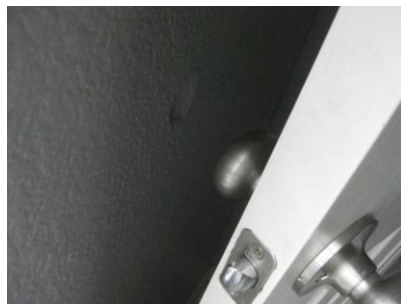
- **Rear Bedroom:** There was a hole in the wall due to the door missing the door stop and the knob hitting wall. Recommend replacing the door stop to prevent additional damage to the wall.

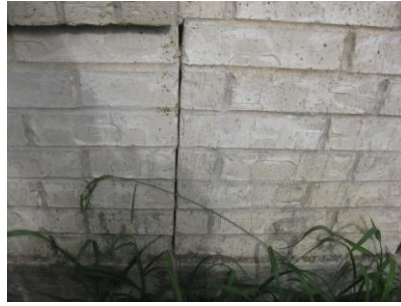
- **Exterior East side:** Expansion joint(s) in brick veneer need caulking. Ensure any mortar present in expansion joint is first removed before sealing.

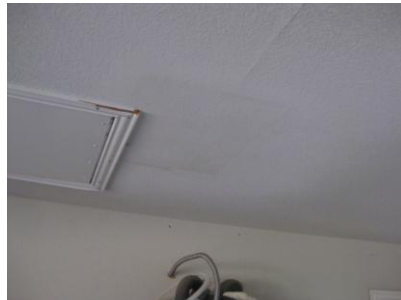
- Upstairs: Past repair seen on the ceiling at tape joint.

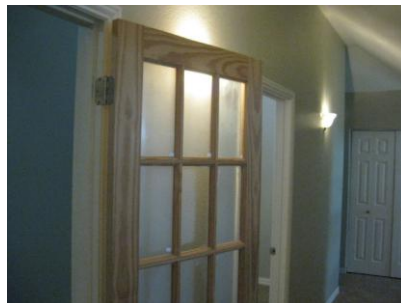
- Upstairs middle bedroom: Doors were not painted or stained.

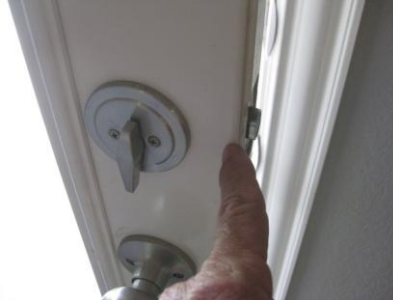
- **Master Bedroom: The middle dead bolt does not extend into the door frame.**

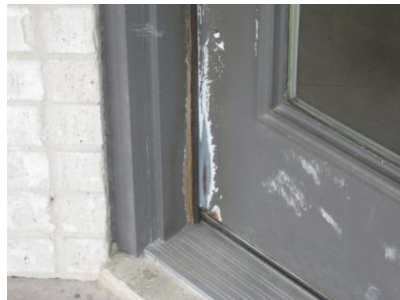
- **Garage: Starting Feb 1, 2022, The TREC requires inspectors to list as deficient, doors between living area and garages that do not have self-closing hinges. Regardless of when the home was built or standards at time of construction.**
- **Back Patio: Pet damage on the door and trim.**

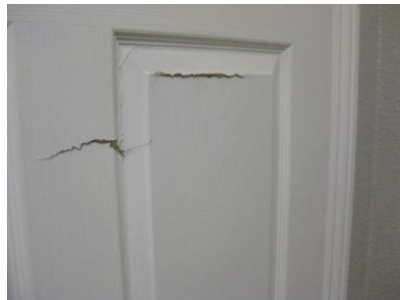
- **Upstairs middle bedroom: Both sides of the door skin was damaged.**

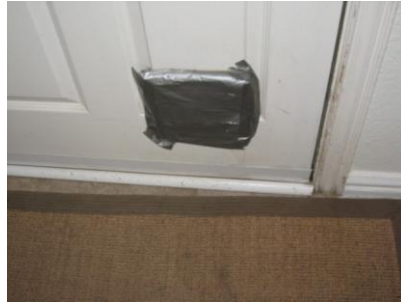
- **Garage: The pet door installed in the garage entry door breaks the required fire separation between garage and living quarters.**

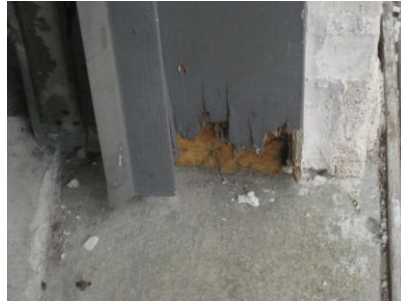
- **Exterior west side: There is moisture/pest related wood rot on the side trim of the overhead garage door near the bottom.**

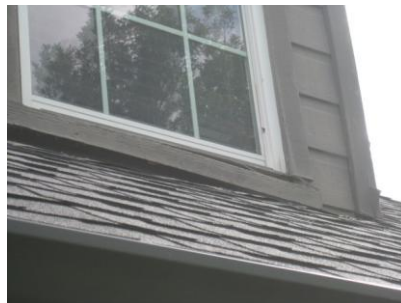
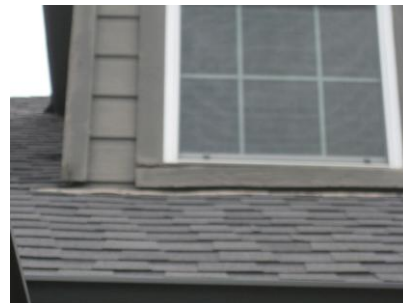
- **Roof: Exterior wood trim board of window has moisture related damage.**

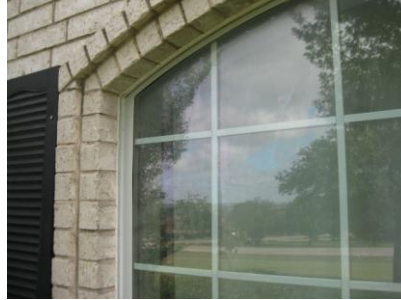
- **SE bedroom: Thermal pane window seal was in the beginning stages of failure and small amounts of moisture have begun to enter between the panes of glass. In time, the windows will need to be replaced as the windows become foggy.**

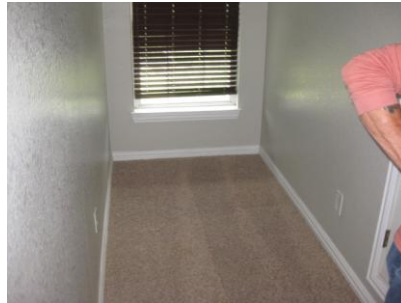
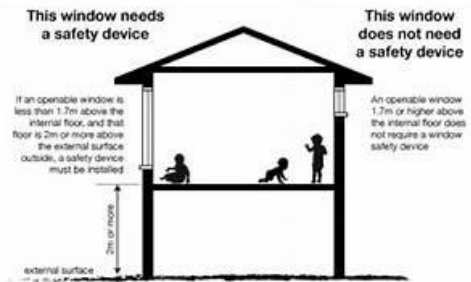
- **Upstairs: Starting 2-1-2022 The TREC now requires reporting the absence of fall protection, in windows that are located less than 24 inches from the finished interior floor and greater than 72 inches from the exterior finished grade as a deficiency. While this may not have violated building practice at the time of construction. These are now a known safety hazard.**

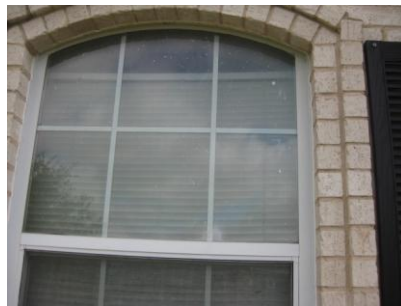
- **Garage:** Thermal pane window seal was in the beginning stages of failure and small amounts of moisture have begun to enter between the panes of glass. In time, the windows will need to be replaced as the windows become foggy.

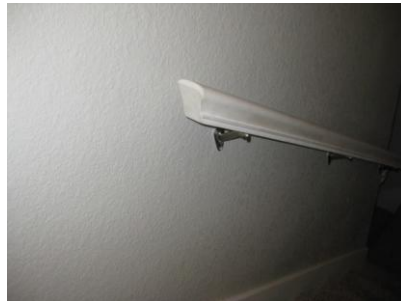
- **Upstairs:** The guardrail at the top of the stairway is loose and needs to be tightened.

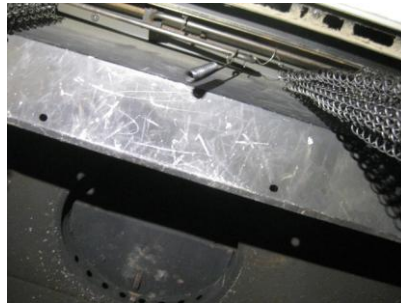
- **Living room: The lever to open and close the damper was missing.**

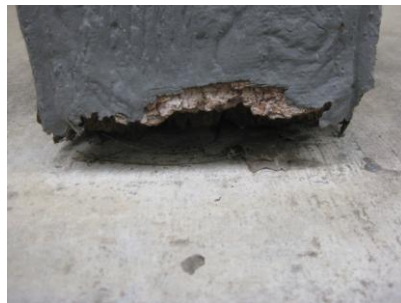
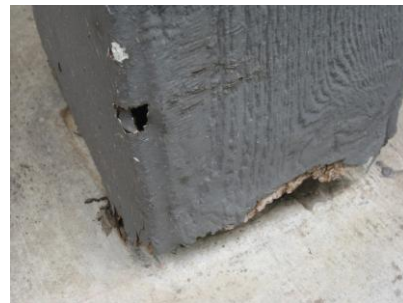
- **Front Entry: The posts that support the front porch cover were mounted directly on the concrete. This had led to pest infestation, wood rot. Recommend being mounted on metal mounting plate.**

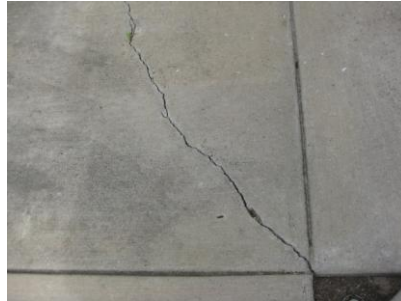
- **Exterior: Large crack was noted in front sidewalk.**

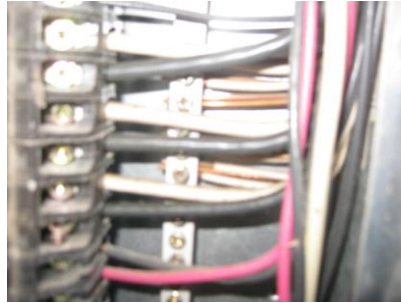
- **Garage: White wires within the panel box that are used as "hot" conductors should be identified. This is commonly done by black tape or marker on the insulation of white wires. Standards require the wires to be identified on both ends.**

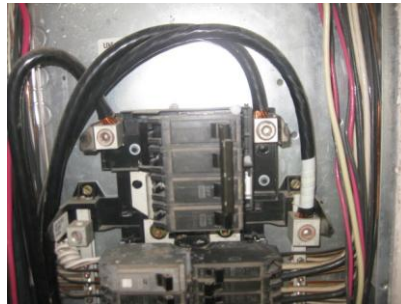
- **Garage: There were no covers on the SE lugs in the panel box. This installation is typical for age of service.**

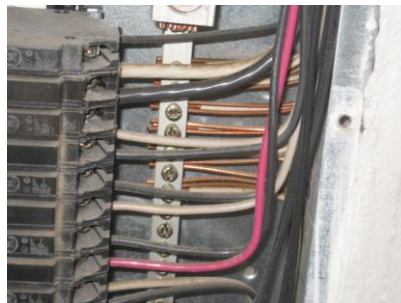
- **Garage: The neutrals (grounded, current carrying conductor- white wires) and ground wires (bare-copper non-current carrying wire) are on same bus bar. Newer standards require them to be separated. This manner of installation does not prevent stray current from being conducted on the grounding wires since it is connected to neutrals. This installation is typical for the age of service.**

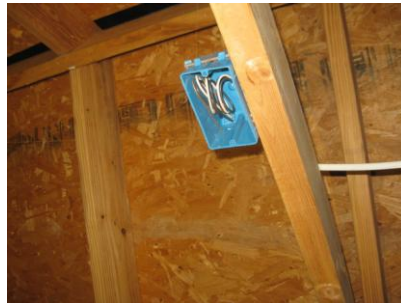
- **Front Entry: The push button was damaged, but the doorbell did sound**
- **Attic above the garage: Junction box was missing the cover plate. They are intended to contain fire and prevent electric shocks from exposed wires. Recommend installing cover plates over junction boxes where missing.**

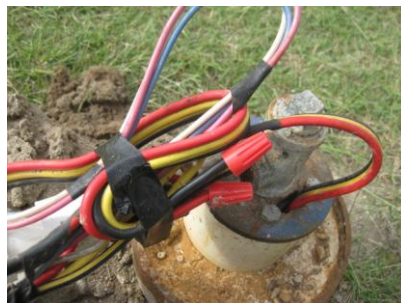
- **Starting 2-1-2022 The TREC requires inspectors to list as deficient any electrical receptacle that is in laundry room and not GFCI protected. There was no GFCI protection for electric dryer receptacles in the laundry room. GFCI protected electric receptacles should be in this area by modern standards.**
- **Exterior: Electrical connection at well head has been incorrectly made outside of a junction box, which is a potential shock-hazard. All such connections should be made inside a junction box.**

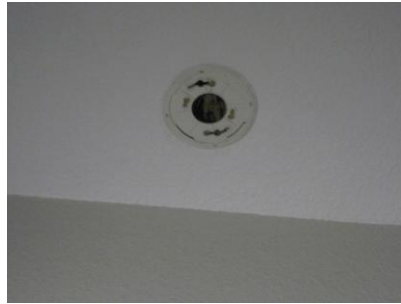
- Attic south side: The smoke alarm was missing from the mounting bracket and should be replaced for safety.

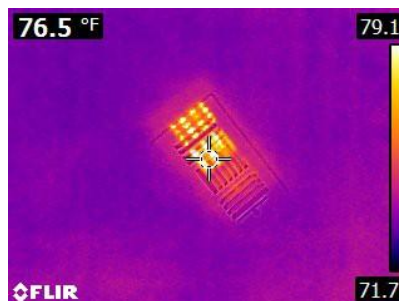
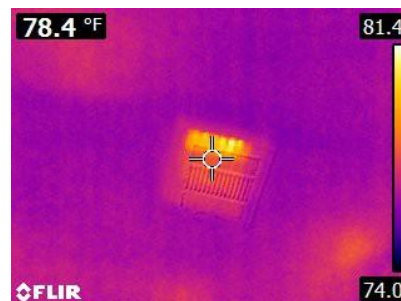
- Upstairs thermostat: **I recommend having a licensed HVAC technician further inspect the system; and make any repairs needed.** Electric heat was tested with little change at registers.

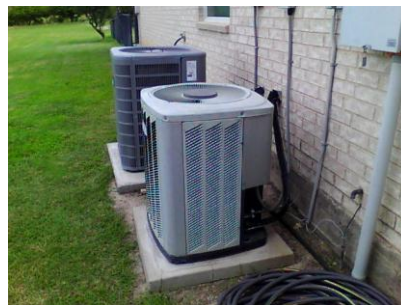
- Exterior west side: Mfg. American Standard  
serial # 61058HK5F  
date March 2006  
Coolant type-R-22  
This equipment is beyond the typical life expectancy range. Standards suggest Air Conditioners will last 8-15 years.

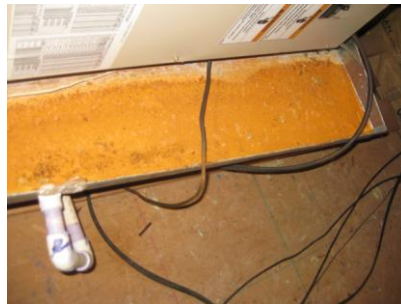
- Attic south side: Evidence of past water in the pan, does not need immediate repairs.

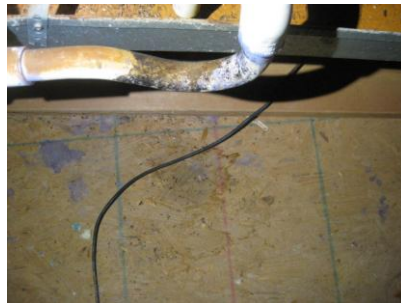
- Attic: The running P trap was not insulated in the attic. The P trap holds cold water from the A coil. The condensation that will form on the pipe exterior often drips onto insulation and the sheet rock below. The standards state. Mechanical system piping capable of carrying fluids above 105°F or below 55°F shall be insulated to a minimum of R-3.

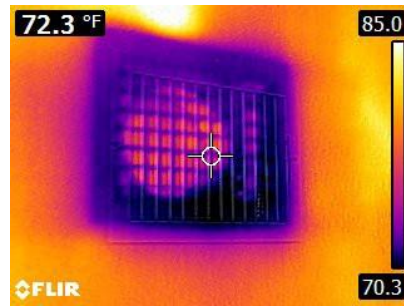
- Upstairs thermostat: Air-conditioning responded, but failed to achieve a 15°F - 22°F degrees, differential temperature split between the air entering the system and that coming out. **This system should be further evaluated and/or serviced by licensed HVAC technician. Equipment is not functioning as intended.**

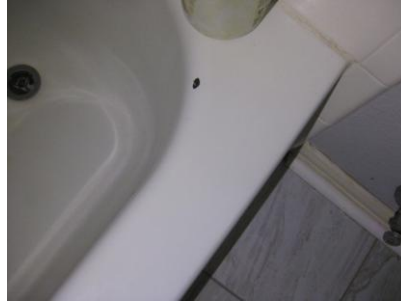
- **Hall bathroom: Small chip on the tub porcelain.**

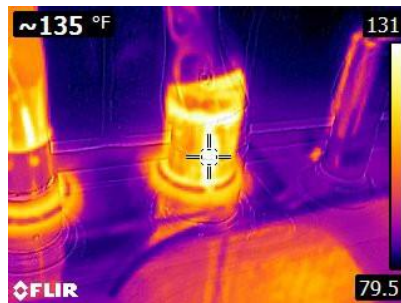
- **Kitchen: Kitchen faucet leaked at stem while in use.**

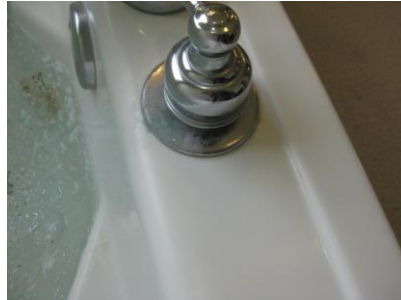
- **Master bathroom: Tub fixture leaked around the stem while in use and should be repaired.**

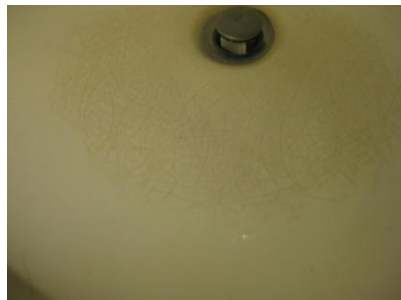
- **Master bathroom: The finish of the sink was damaged, does not appear to be leaking but should be monitored as time passes.**

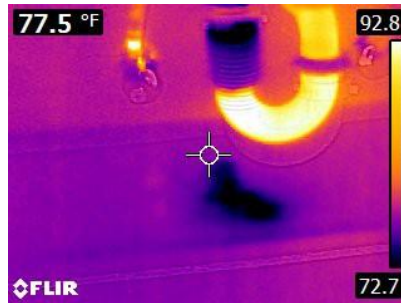
- **Upstairs Bathroom: There is a leak under the sink at the drain line connection to the sink.**

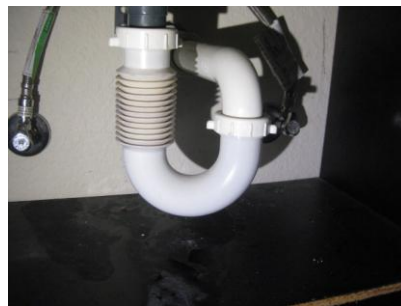
- **Upstairs Bathroom: Sink drain fittings shall have a smooth interior waterway of the same diameter as the piping served. Drainage fittings shall have no ledges, shoulders or reductions which can slow or obstruct drainage flow in the piping.**

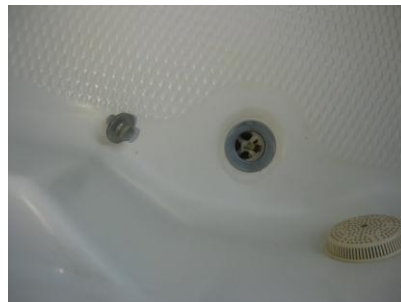
- **Master bathroom: Drain stopper was not attached to tub.**

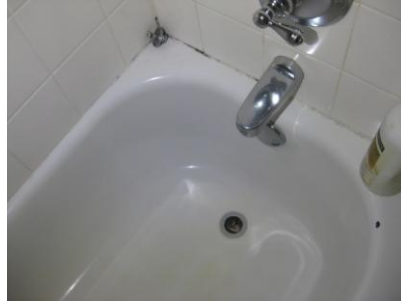
- **Hall bathroom: Drain stopper was not attached to tub.**

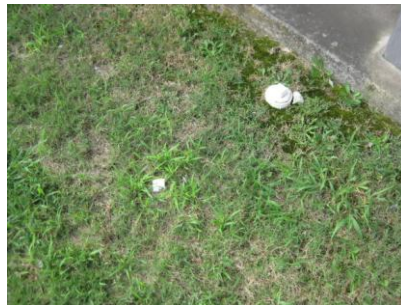
- **Exterior: Minor damage to clean out caps.**

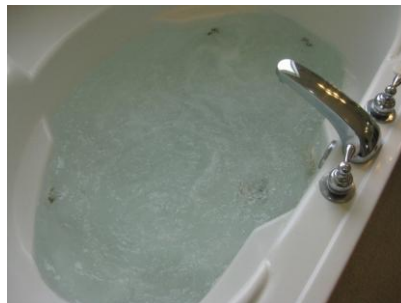
- **Master bathroom: Hydro-therapy tub was turned on and jets activated resulting in the circulation of organic debris in bath water. Recommend flushing system per manufacturer's instructions for sanitary reasons.**

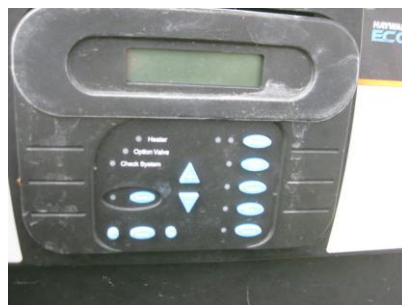
- Exterior: **Recommend having a pool and spa specialist to inspect and make any necessary repairs. The LED display was not visible. Repairs are needed.**

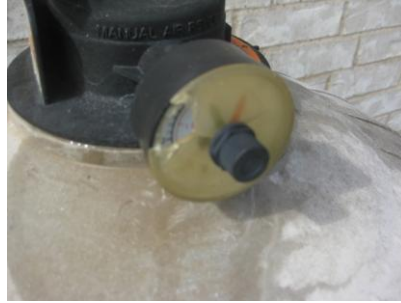
- Exterior: The gauge lens was damaged.

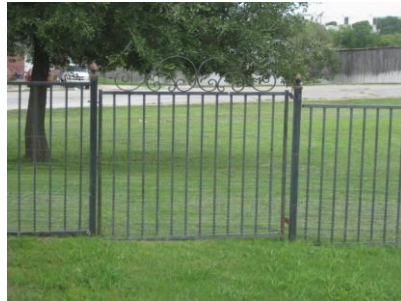
- Exterior: GFCI'S Pool Light Protection - Present I could not confirm the light was functional due to defective LED
- Exterior: Due to the presence of a pool, the gate should be fitted with hardware to make it self closing and latching. This is a child safety and liability issue. Suggest installing specialized alarms (available at pool supply) on all exterior doors that provide access to pool.

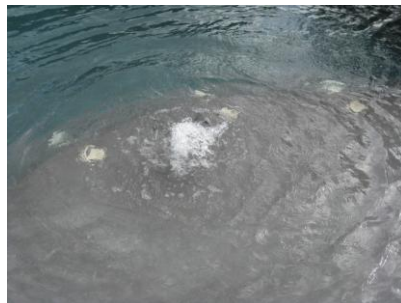
- Exterior: The pumps were functional, but I could not see which aux was labeled as pump and what was labeled as cleaner.

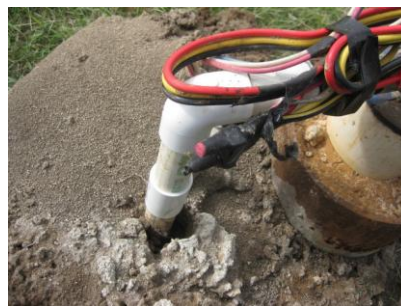
- **Exterior: The well plumbing was not adequately insulated. I recommend having plumbing pipes, insulated to protect against freezing in winter.**

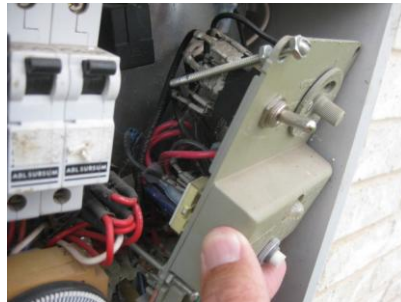
- Exterior west side: The board was not secured within the control head box.
