1306 Timber Ridge  
Weatherford Tx. 76088  
Professional TREC # 8726-PI  
[randall@alertinspector.com](mailto:randall@alertinspector.com)

**Prepared for:** A Happy Client

**Concerning:** 157 Your New Home, Aledo, TX, 76008

# PROPERTY INSPECTION REPORT

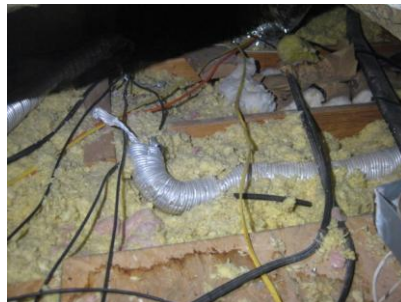
- Attic: There is evidence in the attic of rodents present in the attic due to droppings or tunnels in insulation being present. Recommend having a pest control specialist to inspect the attic. I could not determine if infestation was current or previous activity
- Attic: Attic floor is insulated with approximately six inches of fiberglass, blown insulation. Current standards call for minimum of ten inches, and you may wish to consider adding more for energy efficiency. R -38 is today's standard

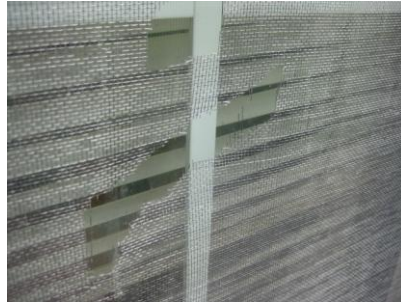
- **Exterior: Some of the screens were damaged.**

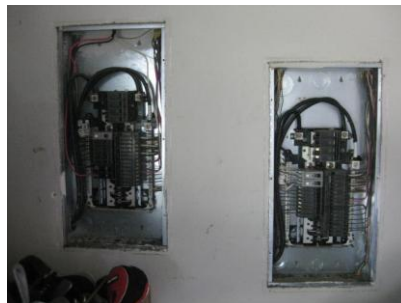
- Garage: Two 200 amp electric service. Copper was used for both the service and the branch wiring.

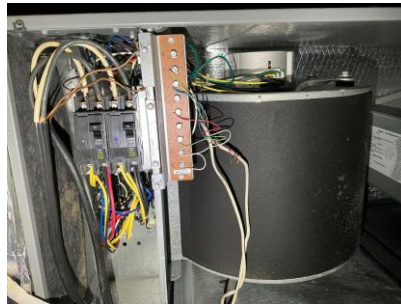
- Attic south side: Mfg. Mastic was on the label and the info could not be read  
serial # 6004J36168  
date Unknown

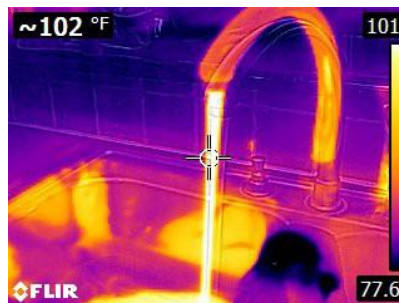
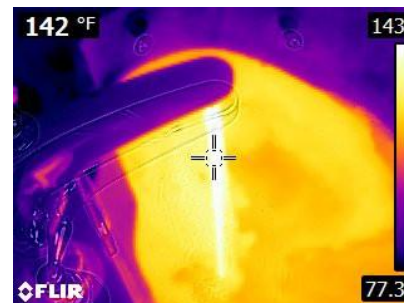
- Garage: Mfg. name AO Smith  
50 gallon Electric  
serial # J04J03902  
Mfg. date-Aug 2004
- Garage: The water heater performed as expected; heated water was delivered to all interior fixtures.

- Garage: The water heater is pretty old and even though it is heating water today it may be nearing its end. Recommend budgeting for a new appliance in the near future due to being past normal, 10-11 years of life expectancy.

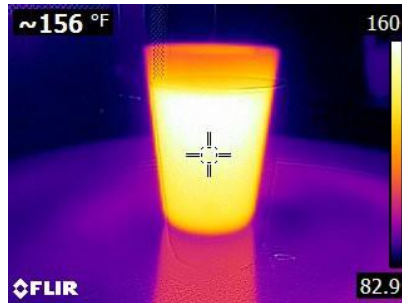
- Kitchen: The microwave functioned properly at the time of inspection. Water was heated and the resulting temperature was 156° F.

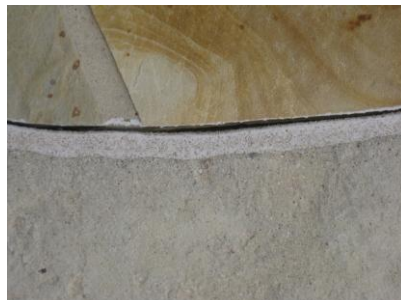
- Exterior: Sealant between coping and the deck need improvements.

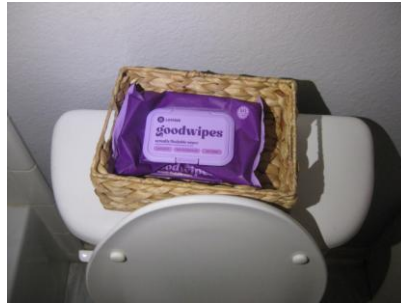
- Interior: I recommend consulting with seller to obtain the history and service records of private wastewater system. If no records are available, I suggest you consider having the tanks pumped empty prior to closing. Wipes were noted in the bathrooms. When these are used with homes on a septic system, the storage tank can become filled prematurely requiring the pumping of the septic tank more often.

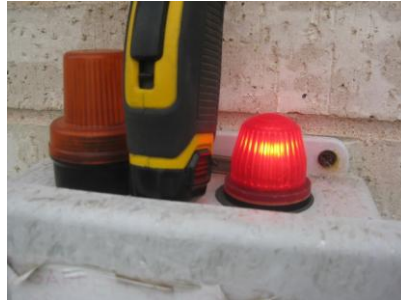
- Exterior west side: The audible alarm failed to sound when test switch was moved. The visual does function.
